TOMPKINS COUNTY PRIORITY LOCATION PROFILES

JULY 2025

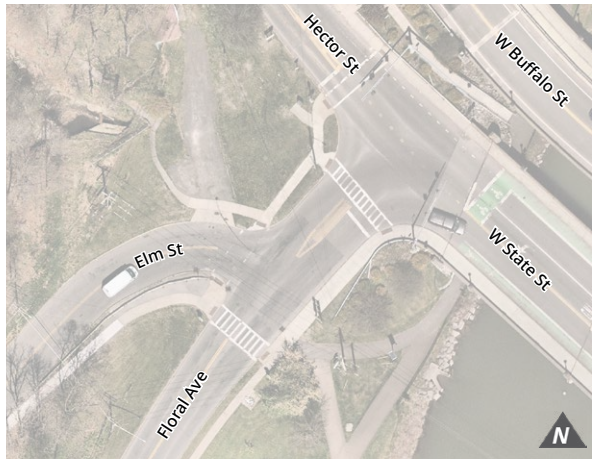
FUNCTIONAL CLASSIFICATION Floral Ave	Urban Minor Arterial
FUNCTIONAL CLASSIFICATION Hector St	Urban Minor Arterial
FUNCTIONAL CLASSIFICATION Elm St	Urban Local Street
AADT Floral Ave	5,816
AADT Hector St	2,774
INTERSECTION TYPE	Urban 3-Leg Uncontrolled TT
SPEED LIMIT	30 MPH
OWNERSHIP	City of Ithaca
ADJACENT LAND USE	Developed-Commercial

Floral Ave, a minor arterial road, is 22-ft wide but expands to 28-ft near the intersection, with a southbound travel lane of 10-ft and a northbound lane of 15-ft. Elm St is local street which is 22-ft wide with two 11-ft travel lanes, one in each direction. Hector St, also a minor arterial road, is 45-ft wide and includes three 10-ft travel lanes, a center turn-only lane and two bike lanes, each 5-ft wide, with bike boxes at the intersection.

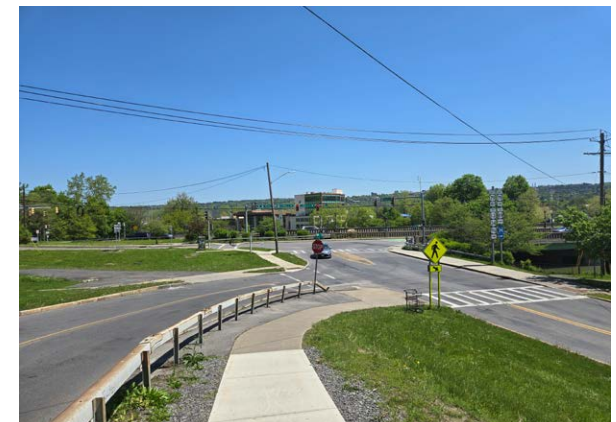
West leg (Elm St)

As per field visit observation, the intersection features a small median and crosswalks, although they are inconsistently marked. Ladder-style crosswalks are present, but there is no marked crosswalk across Elm St or the east leg of Hector St. Sidewalks with accessible curb ramps are present. Traffic control includes a stop sign at Elm St, traffic signals at Floral Ave and Hector St, and a pedestrian signal on the south leg of the intersection. Bike parking is available on Floral Ave near the waterfront.

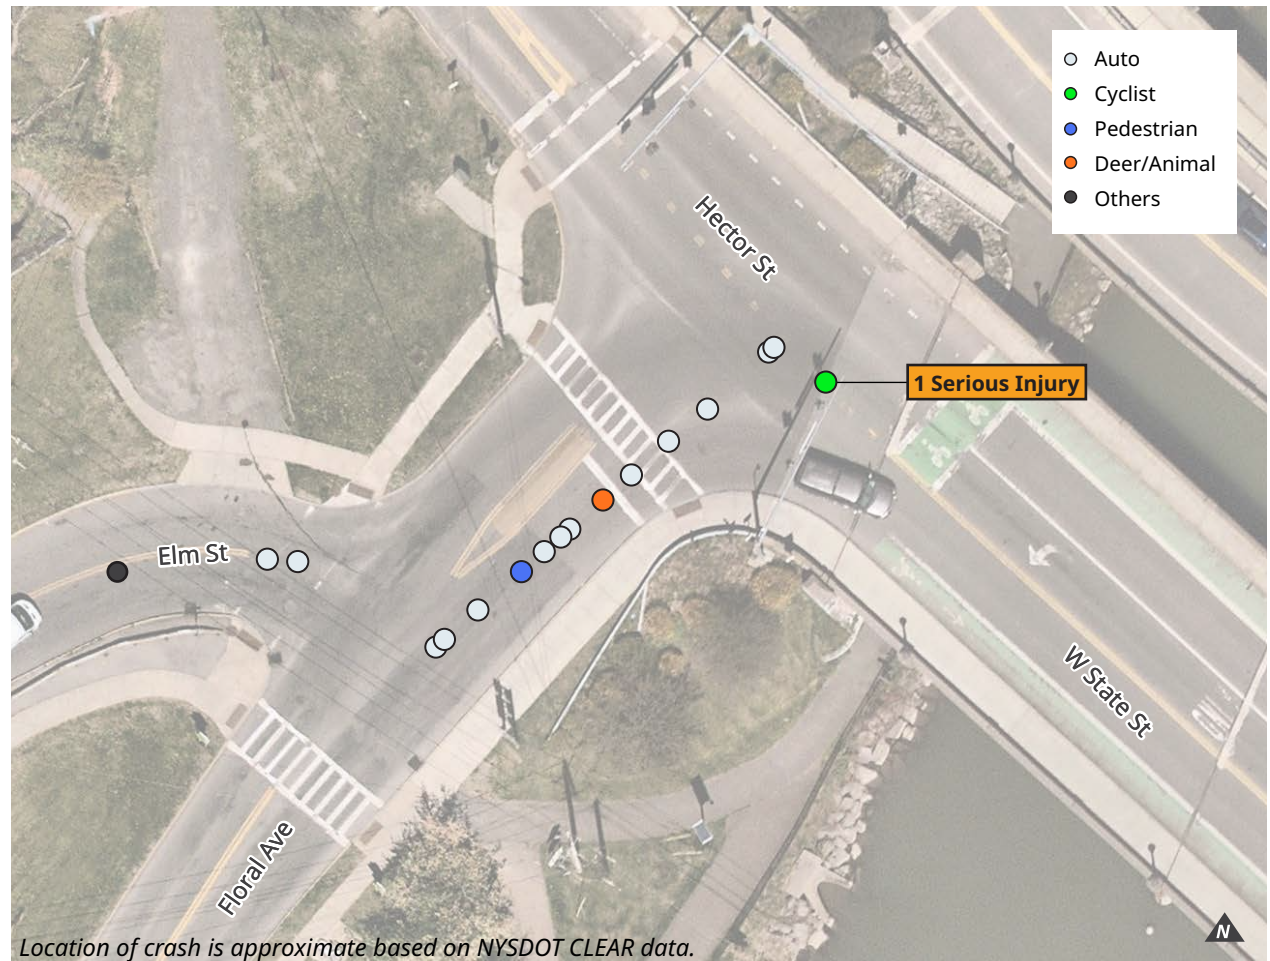
Spatial Distribution of Crashes by User Type

Between 2019 and 2023, 24 crashes occurred at the intersection, with an average frequency of 4.8 crashes per year. Of the 24 crashes, one resulted in a serious injury involving a bicyclist. Contributing factors to the crashes include road user behavior like alcohol involvement and disregard of traffic control devices.

A majority of the crashes that occurred were due to collisions with motor vehicles, one of which resulted in pedestrian injury. Two crashes occurred at the turn of Elm St to Floral Ave. The majority of the crashes occurred on the stretch of Floral Ave between Elm St and Hector St.

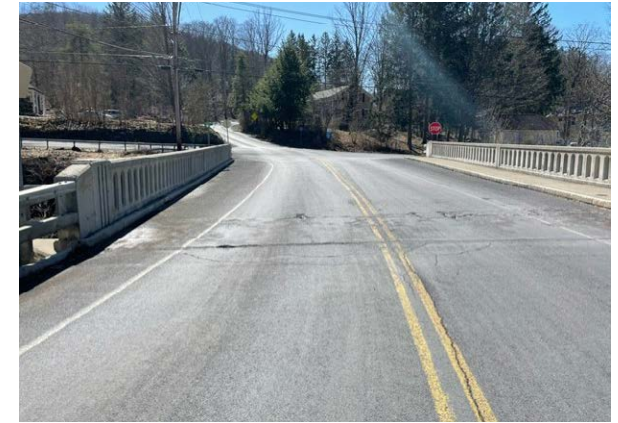
Field observations indicate that the intersection lacks crosswalks and sidewalks, and is controlled by a two-way stop sign across Lounsberry and White Church. A 35-MPH speed limit sign is posted along Valley Rd. The road surface shows minor cracking, and while the pavement markings are somewhat visible, they are faded and lack

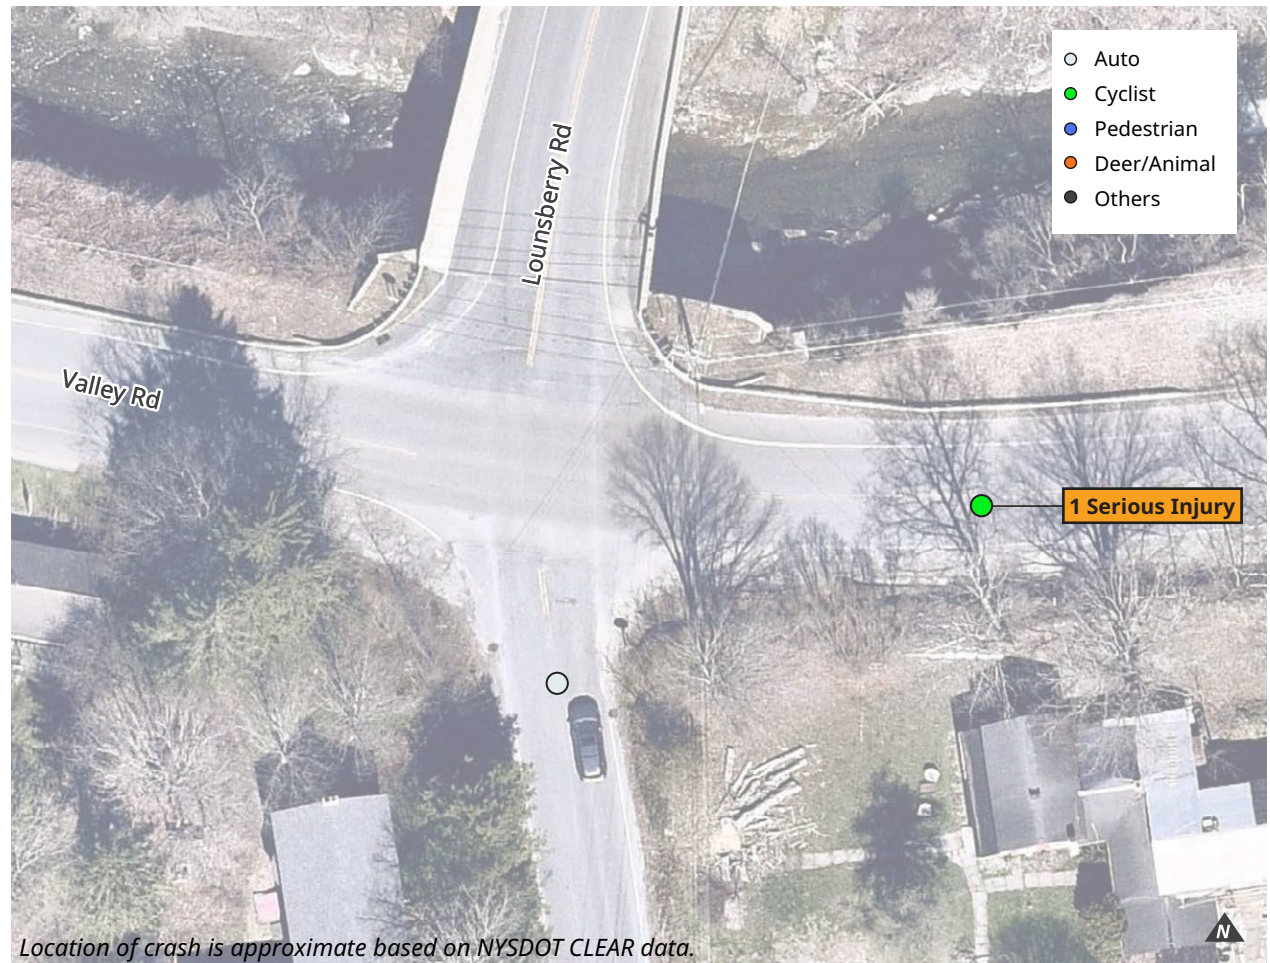
Spatial Distribution of Crashes by User Type

Between 2019 and 2023, two crashes occurred at the intersection. One of them resulted in a serious injury involving a bicyclist. It occurred at the east leg of Valley Rd. The other crash occurred at the south leg of Lounsberry Rd and involved a motor vehicle. Both crashes were noted to have occurred due to failure to yield right-of-way.

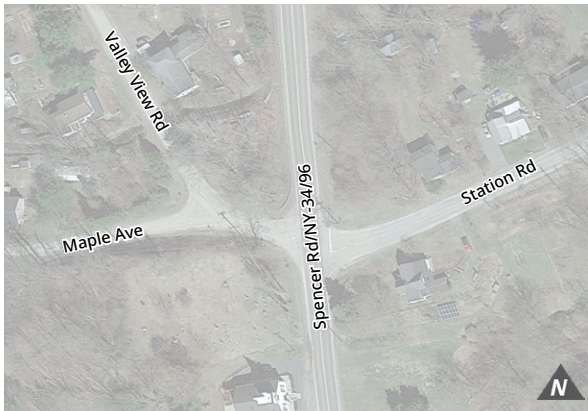
FUNCTIONAL CLASSIFICATION NY-34	Urban Minor Arterial Road
FUNCTIONAL CLASSIFICATION Station Rd	Rural Minor Arterial
FUNCTIONAL CLASSIFICATION Valley View Rd/ Maple Ave	Urban Local Street
AADT Major Street	3,574
AADT Minor Street	201
INTERSECTION TYPE	Rural 4-Leg Stop-Controlled Two-Way Stop TT
SPEED LIMIT	55 MPH
OWNERSHIP	NYS DOT; Tompkins County; Town of Danby
ADJACENT LAND USE	Agricultural/Rural

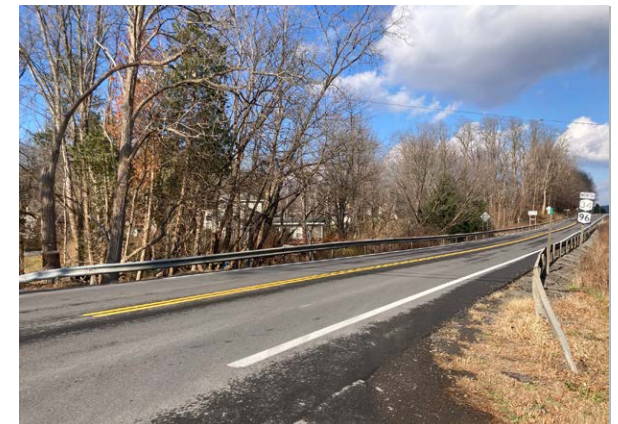
North leg (NY-34/96)

As per field visit observations, the intersection is two-way stop controlled. NY-34/96 has newly paved, clearly visible pavement markings, although they are inconsistent and slightly faded on Station Rd. A portion of Station Rd adjacent to the newly paved NY-34/96 remains unmarked except for stop bars. Station Rd shows minor cracking, while Valley View Rd and Maple Ave are unpaved. The intersection lacks crosswalks, pedestrian or bicycle facilities, and traffic-calming devices. A light post is present, providing illumination.

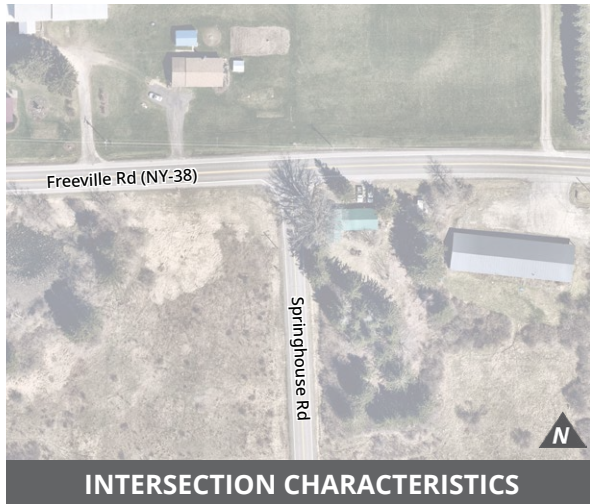
FUNCTIONAL CLASSIFICATION Freeville Rd (NY-38)	Rural Minor Arterial Road
FUNCTIONAL CLASSIFICATION Springhouse Rd	Rural Local Road
AADT Freeville Rd (NY-38)	2,929
AADT Springhouse Rd	1,413
INTERSECTION TYPE	Rural 3-Leg Stop-Controlled Two-Way Stop TT
SPEED LIMIT	35 - 45 MPH
OWNERSHIP	NYSDOT
ADJACENT LAND USE	Developed/ Residential

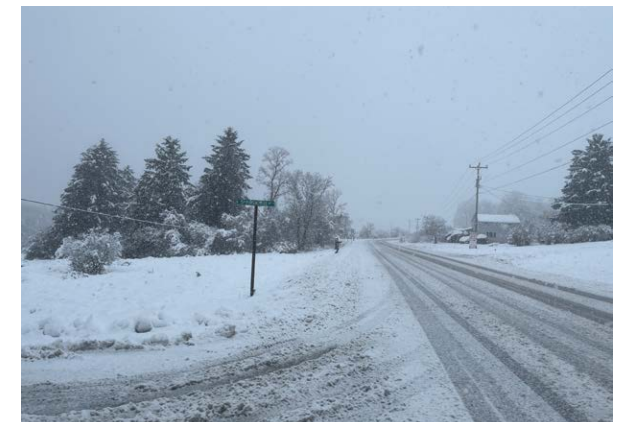
Limited visibility in snow

Field visit observations show that the intersection is controlled by two-way stop signs and features "signal ahead" and "school ahead" signage but lacks crosswalks and sidewalks. There was one bicyclist spotted during site observation. There is a trail system to the south of the intersection that is frequently used. There are no traffic calming devices present at the intersection. Pavement markings on both roads are slightly faded but still visible, and the eastern corner of the intersection exhibits minor cracking. Traffic volumes indicate an AADT of 2,929 vehicles for Freeville Rd and 1,413 vehicles for Springhouse Rd.

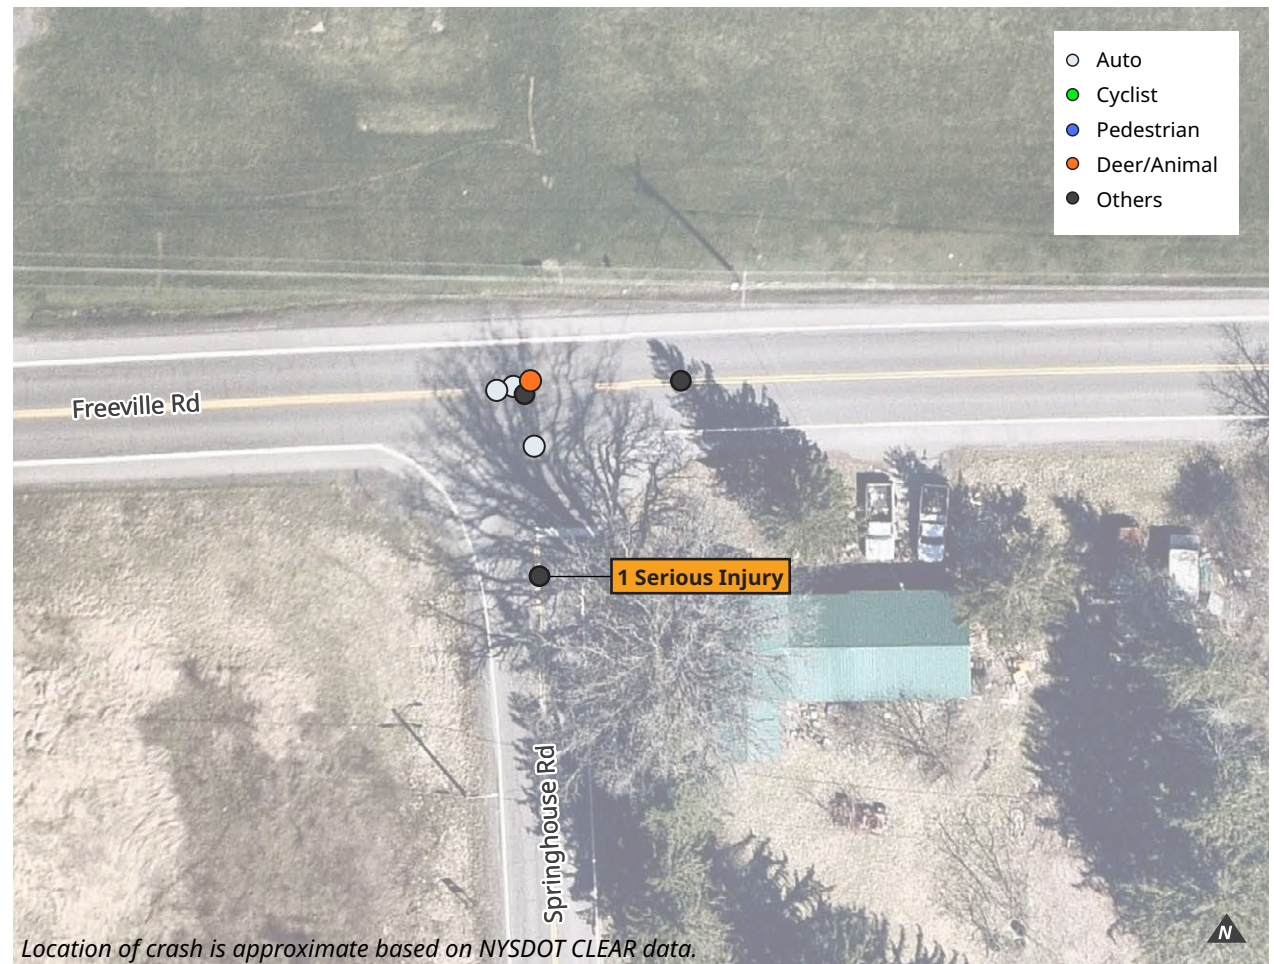
Spatial Distribution of Crashes by User Type

Three of the crashes involved collisions with other motor vehicles, while one crash resulted from a collision with a deer. The primary contributing factors identified were unsafe lane changes, failure to yield the right-of-way, and road user behavior, all of which highlight potential issues related to driver awareness, decision-making, and roadway conditions.

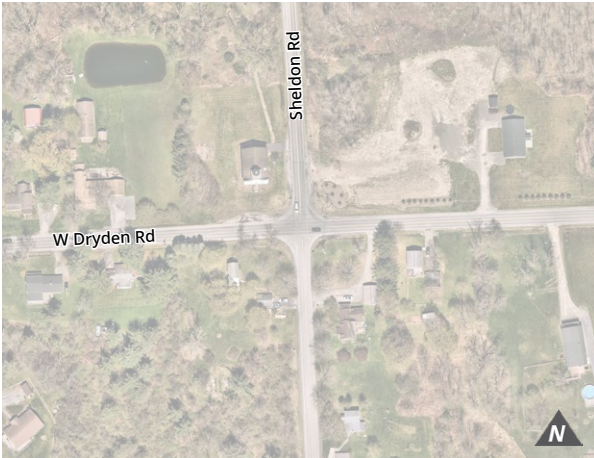
FUNCTIONAL CLASSIFICATION W Dryden Road	Rural Major Collector Road
FUNCTIONAL CLASSIFICATION Sheldon Road	Rural Minor Collector Road
AADT W Dryden Road	2,840
AADT Sheldon Road	582
INTERSECTION TYPE	Rural 4-Leg Stop-Controlled Two-Way Stop TT
SPEED LIMIT	45 MPH
OWNERSHIP	Tompkins County
ADJACENT LAND USE	Rural/Agricultural

The intersection is located in a rural residential area, with a church situated on the northwest corner and driveways from nearby residences feeding into both roads. Sheldon Rd, which is 22-feet wide with two 10-ft travel lanes, is classified as a minor collector road north of the intersection and as a rural local road to the south. W Dryden Rd, a 30-ft-wide major collector road, also features two 10-ft travel lanes, one in each direction.

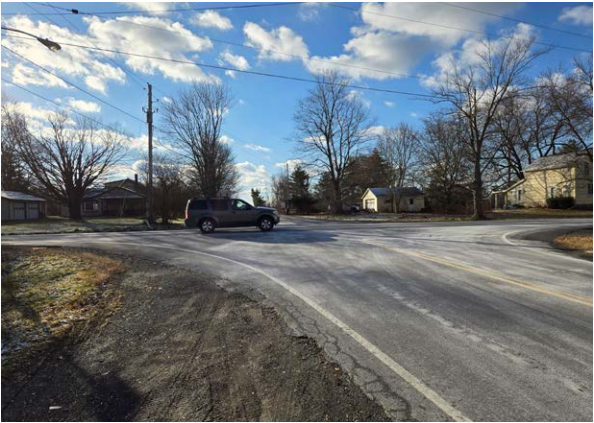
North leg (Sheldon Rd)

As per field visit observations, the intersection is controlled by a two-way stop sign with a flasher and includes a 45-MPH speed limit sign and a yield-to-pedestrian sign. While lane markings are present, the roads lack shoulders and crosswalks. There are no sidewalks present alongside the roads on the intersection. The roads are in good condition with minor cracks on the corner of the intersection.

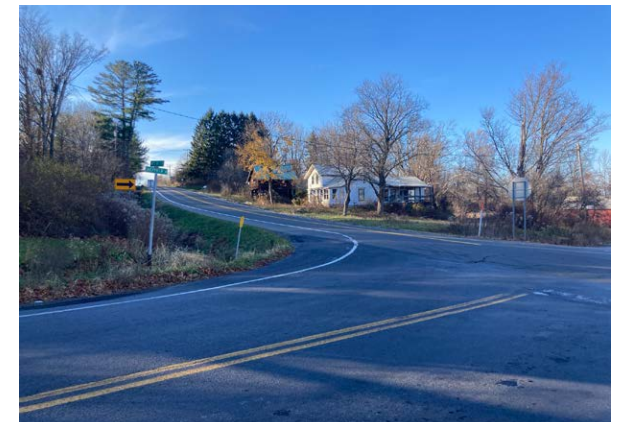
South leg (Sheffield Rd)

As per field visit observations, the pavement marking is slightly faded and the roads are cracked, especially at the corners of the intersection and sides of the roads. Mecklenburg Rd has a bus stop but there are no sidewalks, bike lanes or crosswalks at the intersection. The intersection is surrounded by vegetation and does not leave space for pedestrians. Also, there are no lamp posts at the intersection for visibility in the dark. There are no traffic calming devices present at this intersection.

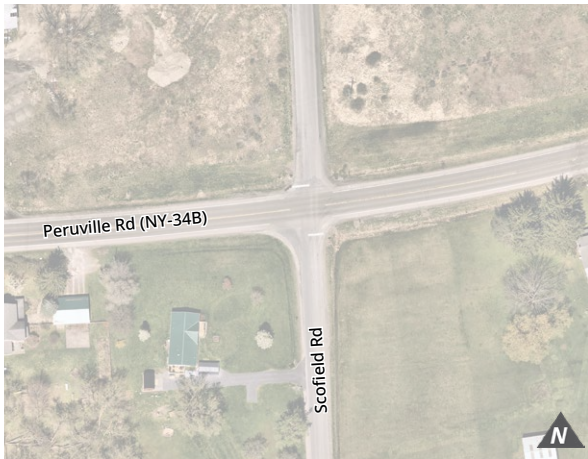
FUNCTIONAL CLASSIFICATION Peruville Rd	Rural Major Collector Road
FUNCTIONAL CLASSIFICATION Scofield Rd	Rural Local Road
AADT Peruville Rd	4,492
AADT Scofield Rd	N/A
INTERSECTION TYPE	Rural 4-Leg Stop-Controlled Two-Way Stop TT
SPEED LIMIT	55 MPH
OWNERSHIP	NYSDOT
ADJACENT LAND USE	Rural/Agricultural

Peruville Rd, the primary road, is approximately 30-ft wide, consisting of two 11-ft travel lanes, one in each direction, and shoulders on both sides. It is classified as a major collector road. Scofield Rd, a rural road, is narrower at 22-ft wide and is unmarked, with the exception of stop lines at the intersection. It is classified as a rural local road. There are no bike lanes or sidewalks on either of the roads.

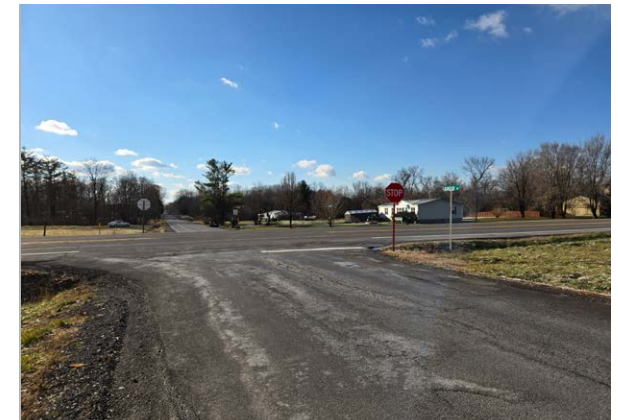
There is minor cracking on the roads and the pavement markings are slightly faded. Scofield Rd is on a slightly lower grade so the visibility from Scofield Rd towards Peruville Rd is difficult.

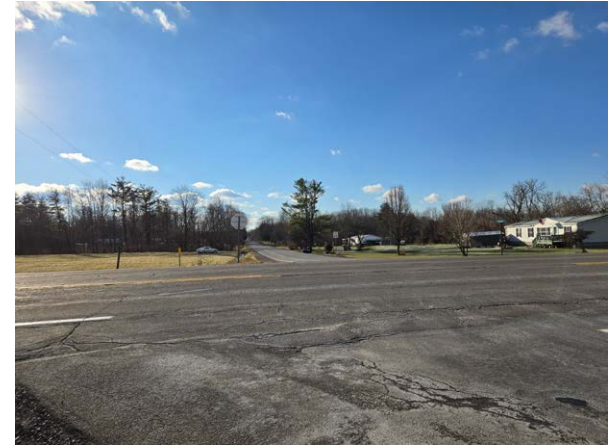
Poor road conditions

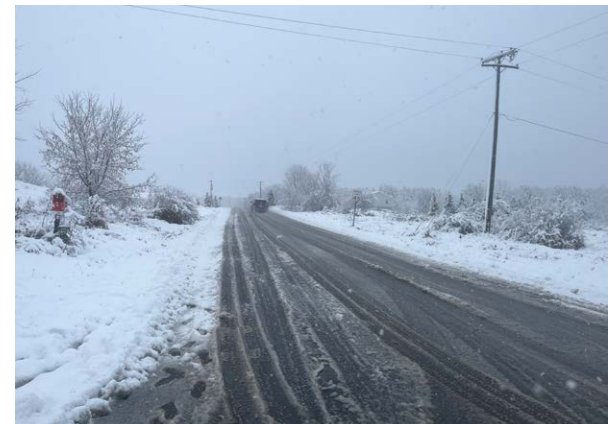
Limited visibility in snowy weather

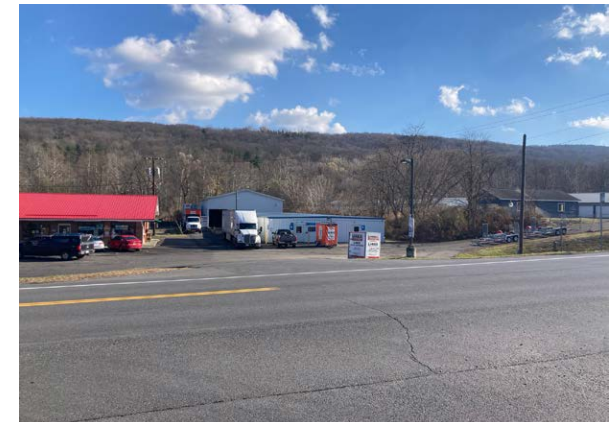
South leg (W Danby Rd)

The field visit observations show that the intersection has no crosswalks. There is a bus stop sign on West Danby Rd and a “bus stop ahead” sign approaching the intersection. There are no sidewalks or bike lanes on the road. There are streetlights illuminating the adjacent business driveways but not the roadway. The access from the gas station is on a slightly lower elevation and limits visibility for those existing the driveway. During the field visit it was noted that the surface of Decker Rd is cracked and covered with gravel with slightly visible markings.

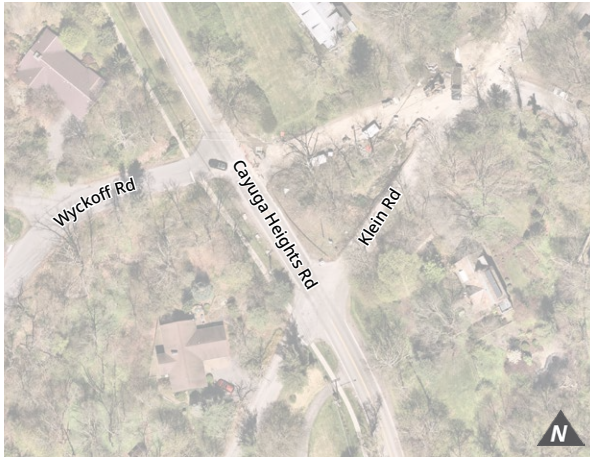
FUNCTIONAL CLASSIFICATION Cayuga Heights Rd	Urban Major Collector Road
FUNCTIONAL CLASSIFICATION Wyckoff Rd	Urban Local Road
FUNCTIONAL CLASSIFICATION Kline Rd	Urban Local Road
AADT Cayuga Heights Rd	1,346
AADT Wyckoff Rd	N/A
INTERSECTION TYPE	Urban 4-Leg Stop-Controlled
SPEED LIMIT	30 MPH
OWNERSHIP	Village of Cayuga Heights
ADJACENT LAND USE	Developed/ Residential

The intersections of Wyckoff Rd and Cayuga Heights Rd and Kline Rd are four-legged, stop-controlled junctions located in an urban residential neighborhood. Cayuga Heights Rd is classified as a major collector road, while Wyckoff Rd is an urban local road. The intersection is under the jurisdiction of the Village of Cayuga Heights. Wyckoff Rd and Kline Rd are 20-ft wide and unmarked roads, whereas Cayuga Heights Rd features two 9-ft-wide travel lanes, one in each direction. Wyckoff Rd is slightly offset, creating a subtly angled alignment at the intersection. Kline Rd intersects with Cayuga Heights Rd 100-ft south of Wyckoff Rd. Multiple residential driveways feed into both streets.

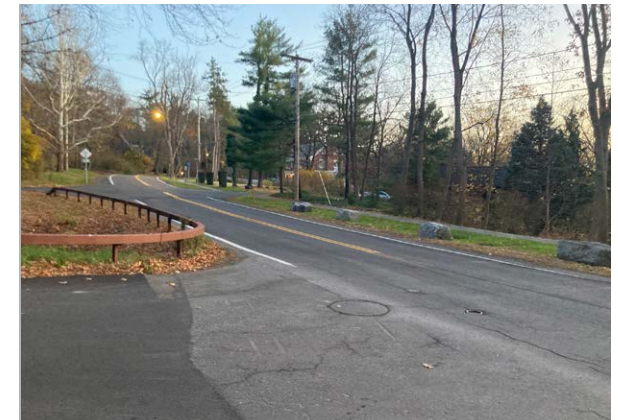
North leg (Cayuga Heights Rd)

As per field visit observations, the Wyckoff Rd and Cayuga Heights Rd intersection features a two-way stop sign, accompanied by a crosswalk sign and a yield-to-pedestrian sign on the approach. High-visibility crosswalks are present on two legs of the intersection. The Kline Rd and Cayuga Heights Rd intersection is also two-way stop controlled and crosswalks are absent from the intersection. During the field visit, it was noted that the single lamp post at the Wyckoff Rd intersection provided inadequate illumination at night. Both roads have sidewalks, but they are incomplete. Sidewalks are present on only one side of Wyckoff St (north), one side of Cayuga Heights Rd and no sidewalks are present on Kline Rd. The pavement markings are clearly visible on Cayuga Heights Rd but lack consistency. Only stop bars are present on Kline Rd and Wyckoff Rd. The roadway shows minor cracking.

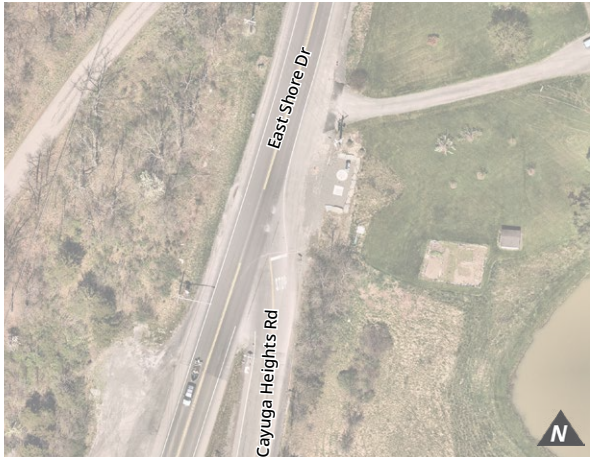
FUNCTIONAL CLASSIFICATION East Shore Dr	Urban Minor Arterial
FUNCTIONAL CLASSIFICATION Cayuga Heights Rd	Urban Major Collector
AADT East Shore Dr	6,999
AADT Cayuga Heights Rd	793
INTERSECTION TYPE	Urban 4-Leg Stop-Controlled
SPEED LIMIT	30 MPH
OWNERSHIP	NYSOT
ADJACENT LAND USE	Rural/Residential

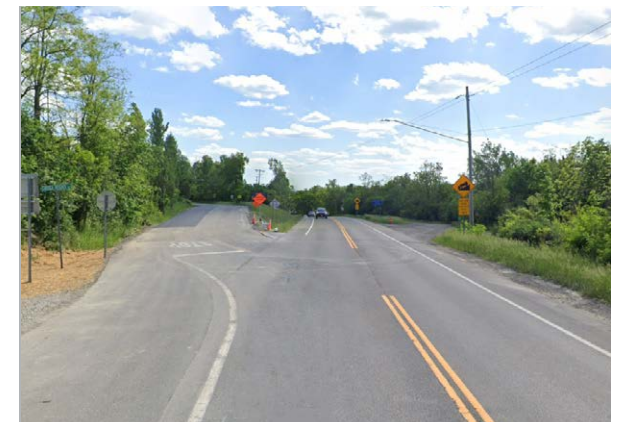
Intersection (Google Maps)

Cayuga Heights Rd and East Shore Dr are stop-controlled at the intersection. There is a curve ahead sign on East Shore Dr in the northbound direction. A residential driveway opens into East Shore Dr 100 feet north of the intersection and has a two-way traffic sign on the East Shore Dr for northbound traffic. There is a stop sign near the intersection for northbound traffic from Cayuga Heights Rd. The lane markings are present but are slightly faded. The shoulder lane markings

on Cayuga Heights Rd are not clearly visible. There are no sidewalks or crosswalks present at the intersection. West of the intersection is a gravel lot. There is a streetlight present at the intersection.

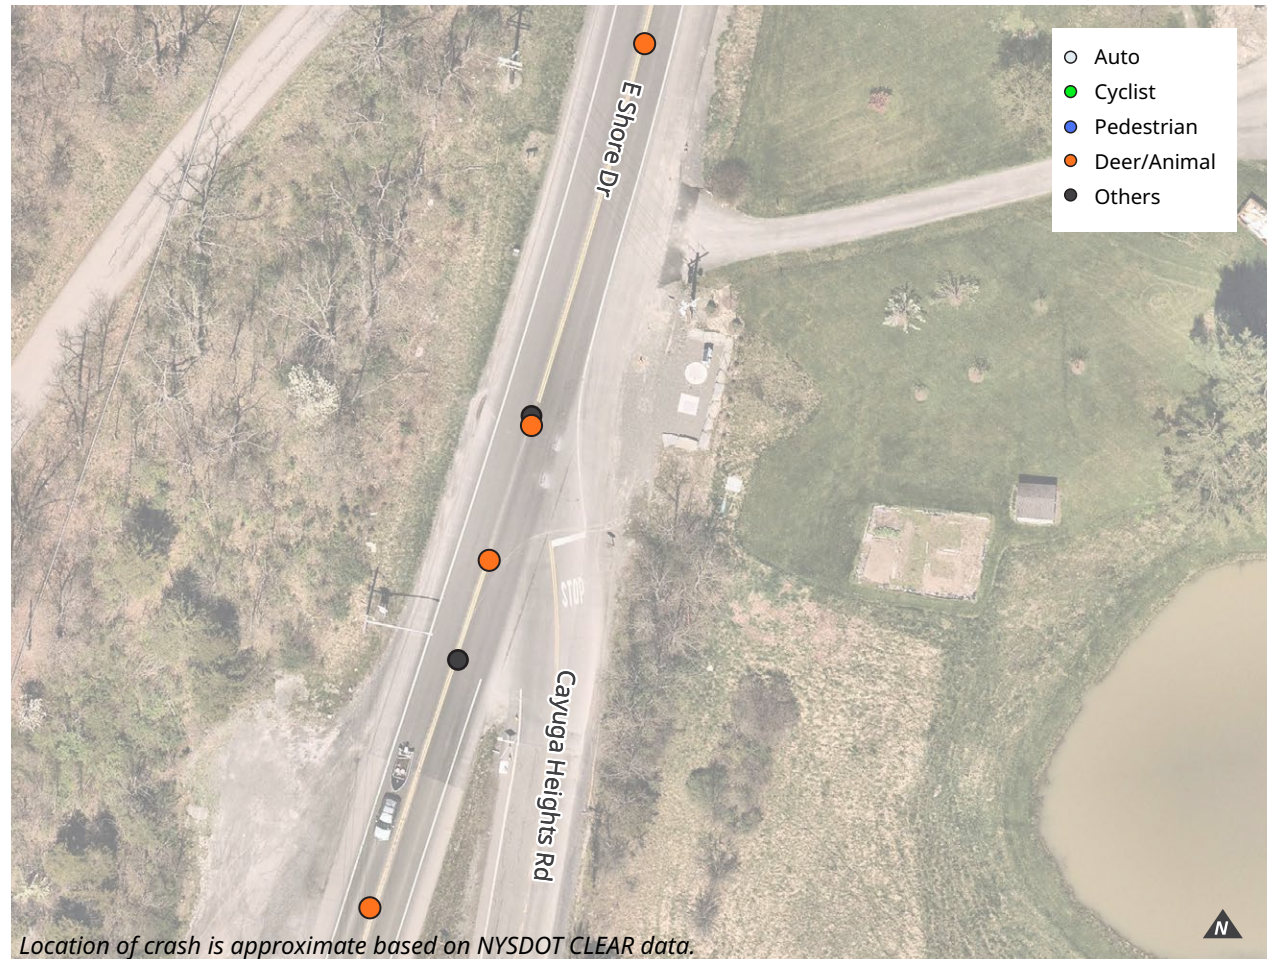
Spatial Distribution of Crashes by User Type

Between 2019 and 2023, the intersection experienced seven crashes, with an average crash frequency of 1.4 per year. Five crashes out of seven were deer or animal related crashes. One of those resulted in possible injury. The other crashes resulted in vehicle damage. The contributing factors, apart from animal action, involved are alcohol impairment and failure to yield.

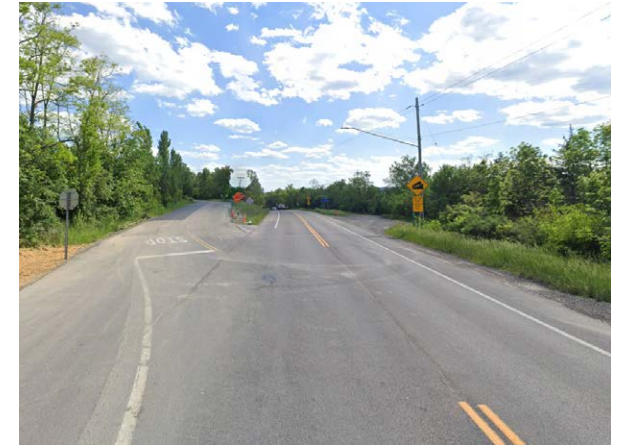
South leg (East Shore Dr) (Google Maps)

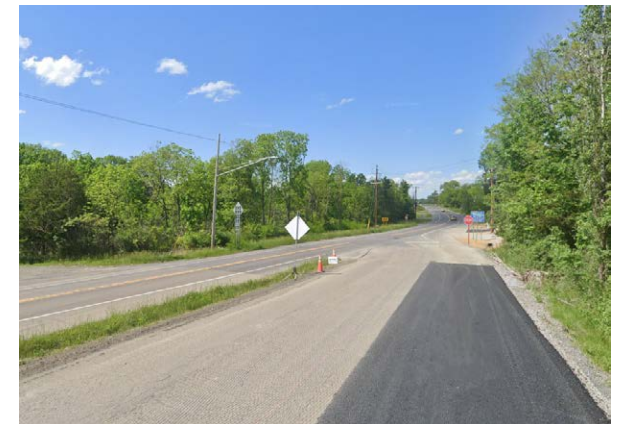
Cayuga Heights Rd (Google Maps)

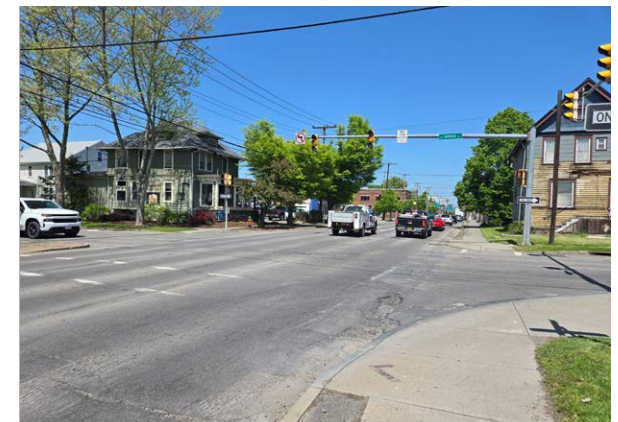
Green St and Meadow St intersection

The West Seneca and NY-13 NB intersection has ladder style crosswalk on east and west legs but has parallel line crosswalk on north and south legs. The crosswalk markings are partially visible. Similar conditions are present on the other two intersections.

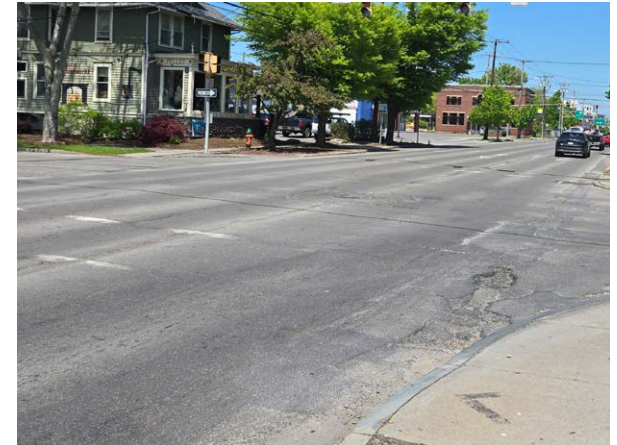
Green St and Meadow St intersection

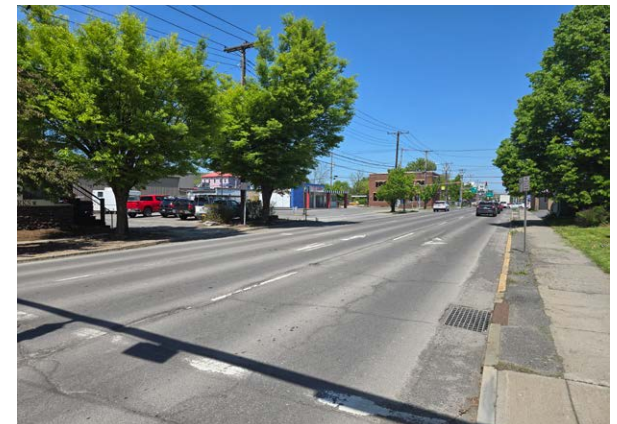
As per field visit observations, the lane markings are present but accompanied by severe surface cracking. Pedestrian signals are provided at the West Seneca St and West Green St intersections, but not at West State St. Sidewalks are present but damaged, while crosswalks are inconsistently marked, with some intersection legs lacking crosswalks. During a site visit in December 2024, the segment exhibited moderate congestion.

South leg (Meadow St)

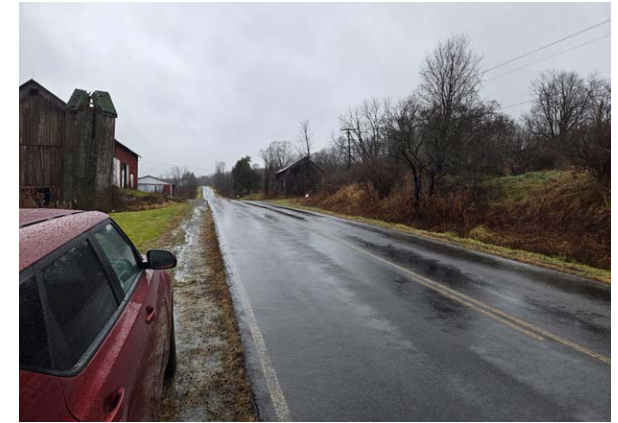
As per the field visit observation, there is minimal signage along the entire segment. The lanes are marked, and no shoulders are present on the segment. The edge of pavement is in poor condition, with sections partially visible, and the road surface exhibits signs of infrequent and minor cracking. There are no pedestrian facilities or traffic calming features.

North leg (Seventy Six Rd)

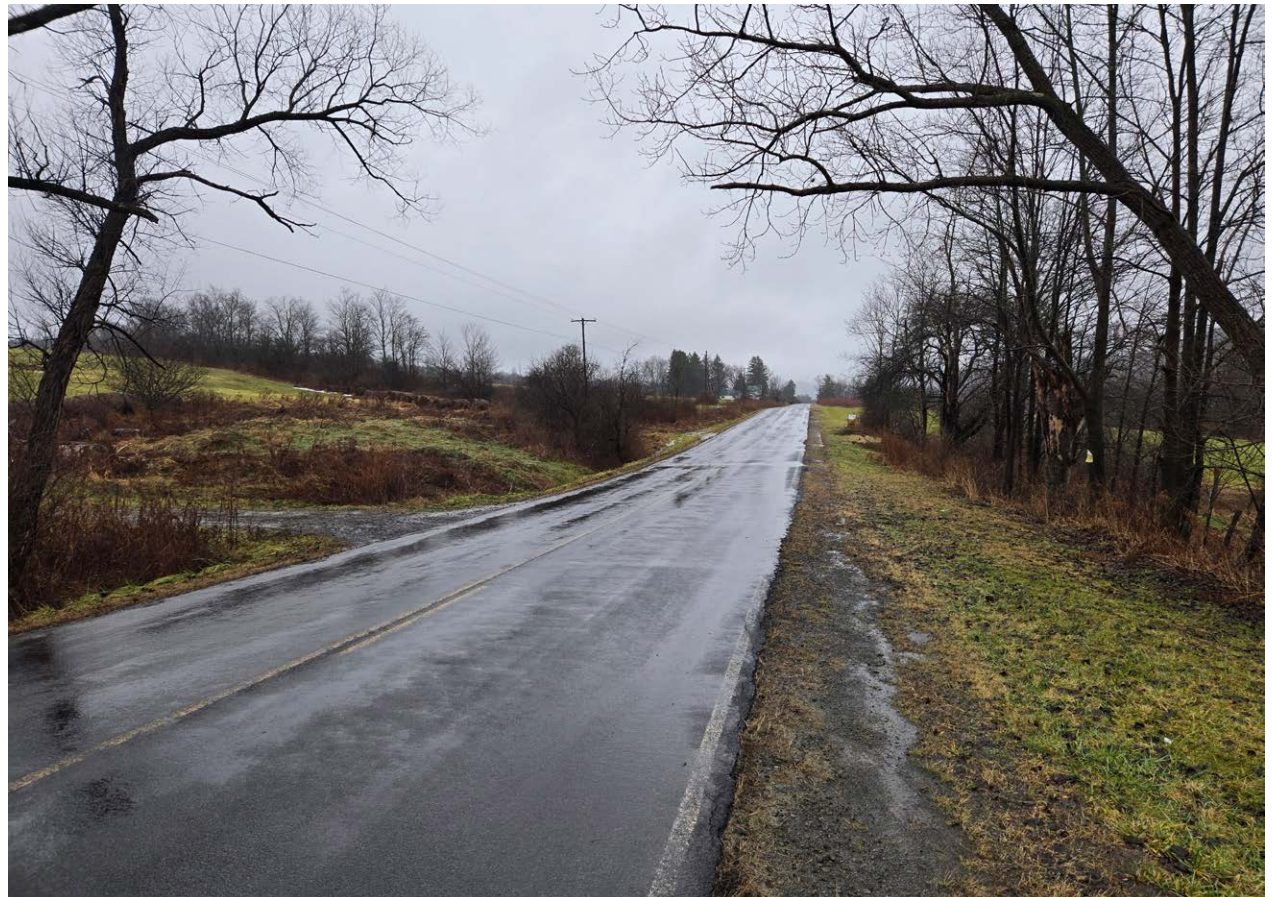
South leg (Seventy Six Rd)

Wider edge lines enhance the visibility of travel lane boundaries compared to traditional edge lines. It is recommended to increase the edge lines are from traditional 4 inches width to width of 6 inches to enhance visibility of travel lanes to the driver.

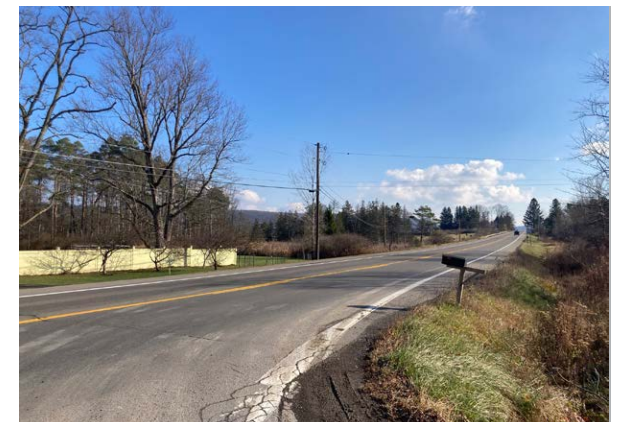
North leg (Danby Rd)

As per the field visit, the lane markings and shoulders are present and clearly visible, and the pavement markings are in excellent condition. The road surface was newly paved as of November 2024 and is in excellent condition. During the site observation, a jogger was noted running along the shoulder of NY-96B. There are no sidewalks or crosswalks or other pedestrian facilities at any of the intersections.

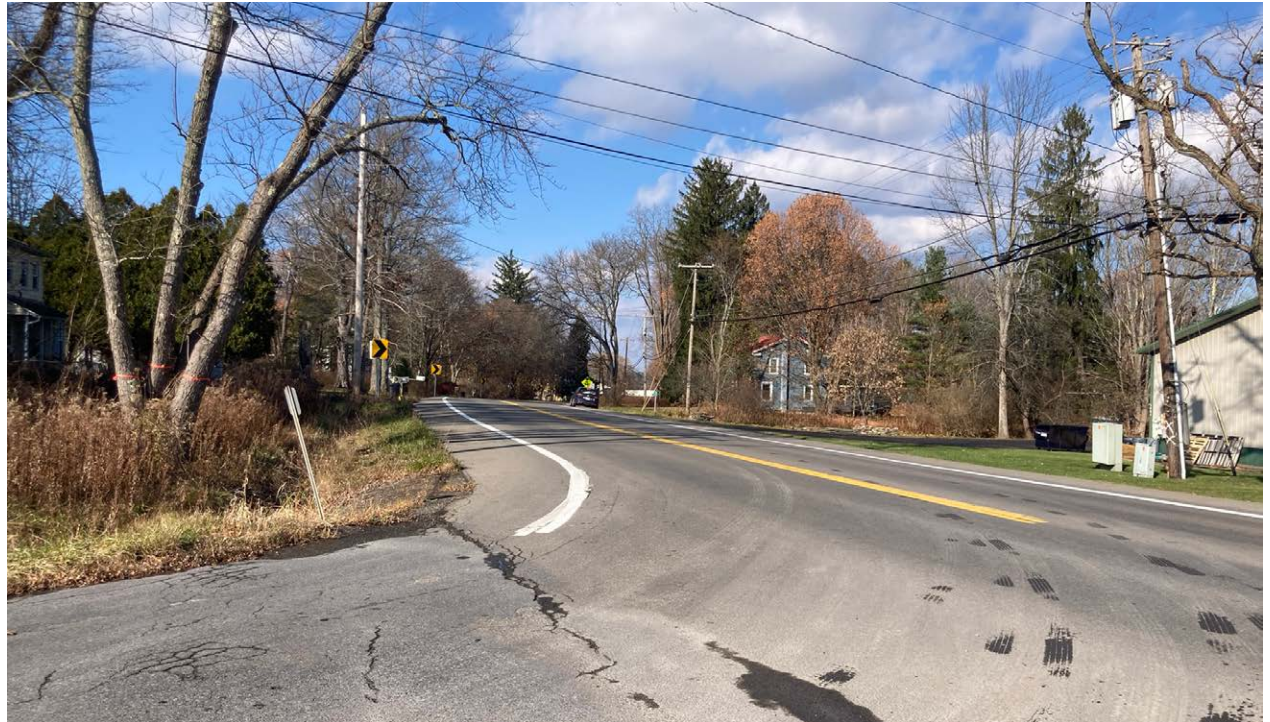
South leg (Danby Rd)

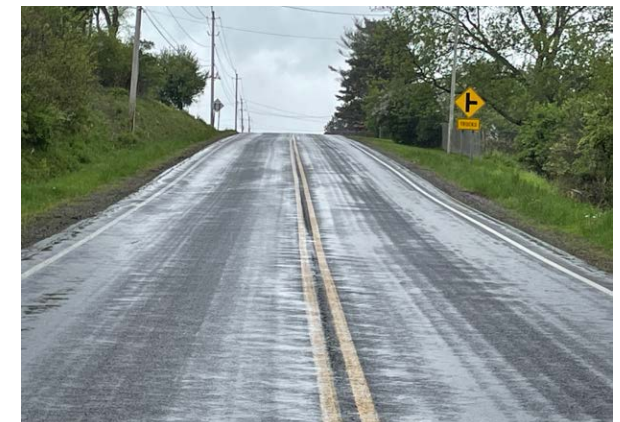
South leg (North Rd)

and has no crosswalk or sidewalk, though a stop sign is present. Similar conditions are observed at Annee Ln and Mott Rd, where markings are faded or absent. At its southern terminus, North Rd intersects NY-13 at an acute angle and merges directly into it. No pedestrian facilities are present at any intersection.

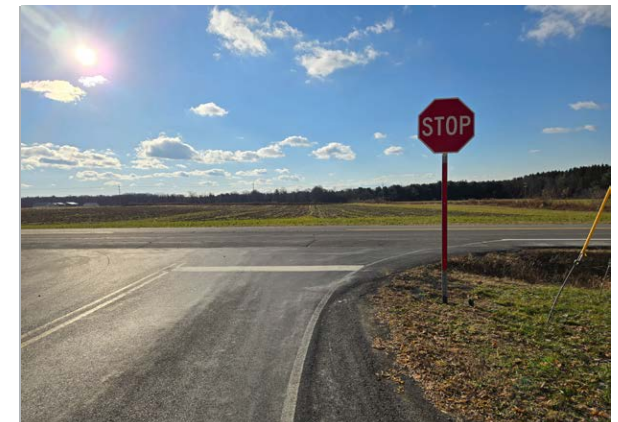
Lane markings are present but slightly faded, with signs of infrequent minor cracking on the road surface. Sidewalks are present but inconsistent and interrupted by drainage pipe openings along the roadside. There are no crosswalks at any intersection. The segment is a flat, straight roadway with decent sightlines, providing generally good visibility for drivers.

Intersection of Van Ostrand Rd & Peruville Rd

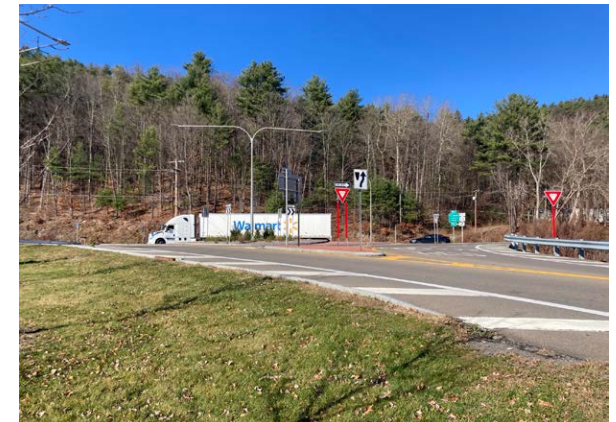
Multiple yield signs are present near the roundabout. Outside of the roundabout, side streets approaches are stop-sign controlled.

As per field visit observations, the lane markings are clearly visible, and the road surface is in excellent condition, with no cracking. No sidewalks are present at any intersection, including Bank St, which meets the segment at an acute angle. During the field visit, a significant volume of construction truck traffic was observed.

Roundabout

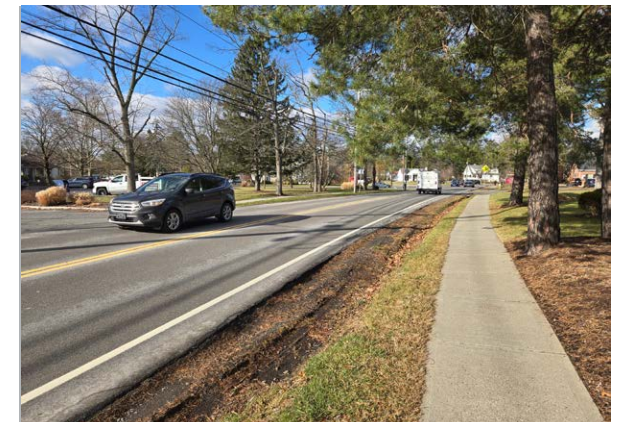
As per the field visit observations, the lane markings are clearly visible, and the road surface shows infrequent minor cracking, especially on the sides and corners of the intersection. Sidewalks run along the entire segment of Hanshaw Rd, however, at some sections there are drainage pipes openly present along the sidewalk. Additionally, crosswalks are present but at some legs of the Triphammer Rd and East Upland Rd intersection, as well as along Hanshaw Rd between East Upland Rd and Pleasant Grove Rd. These crosswalks are ladder-style with slightly faded markings and accessible curb ramps, though the ramps lack tactile surfaces.

West leg (Hanshaw Rd)

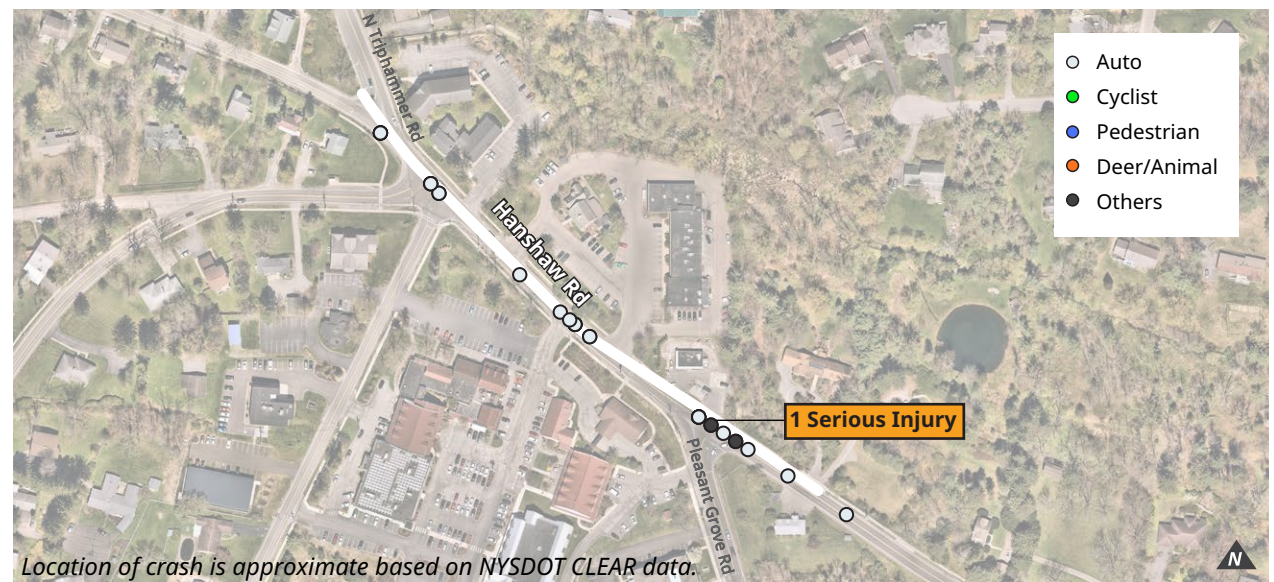
Most crashes involved collision with motor vehicles and were concentrated near the intersection or approach of the intersection.

Spatial Distribution of Crashes by User Type

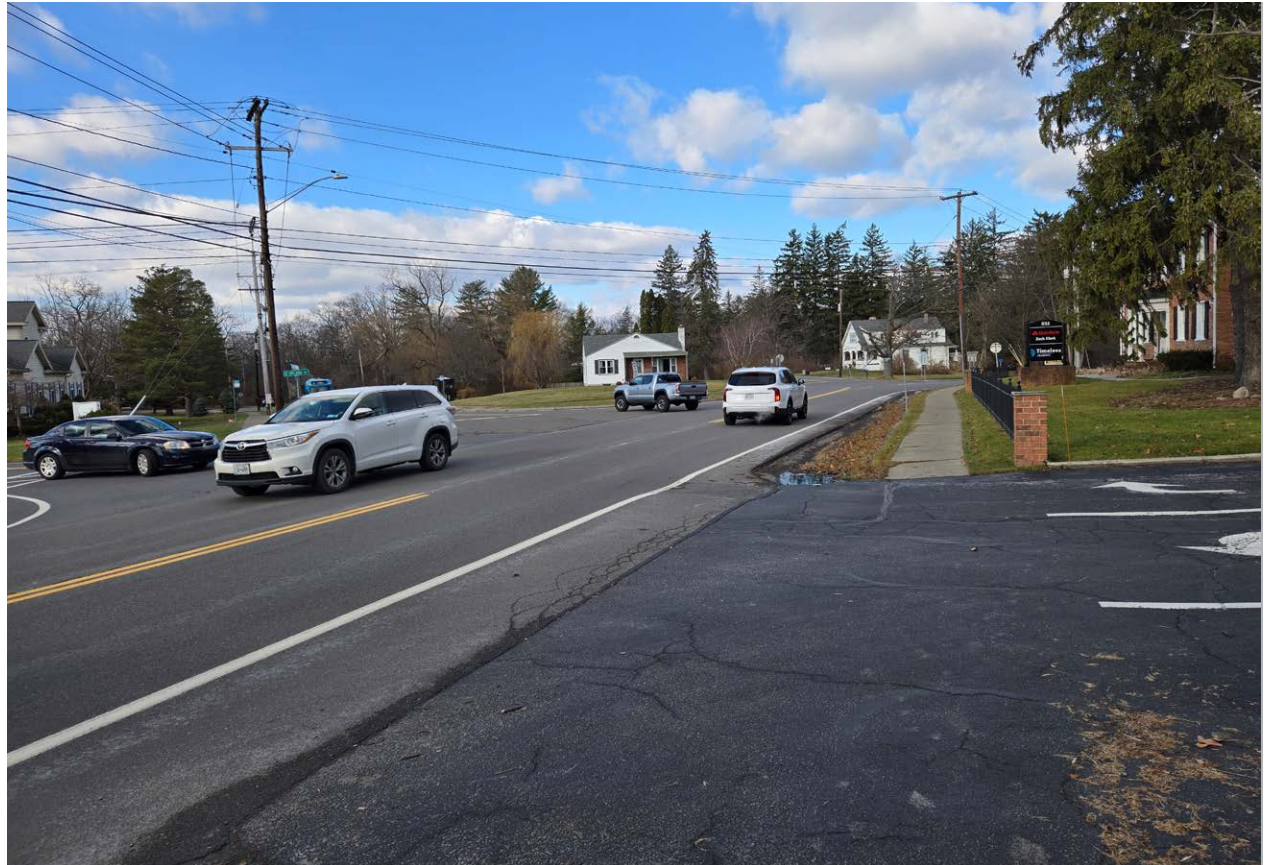
Intersection of Hanshaw Rd & E Upland Rd

Access management refers to the design, application, and control of entry and exit points along a roadway. Access management along a corridor can simultaneously enhance

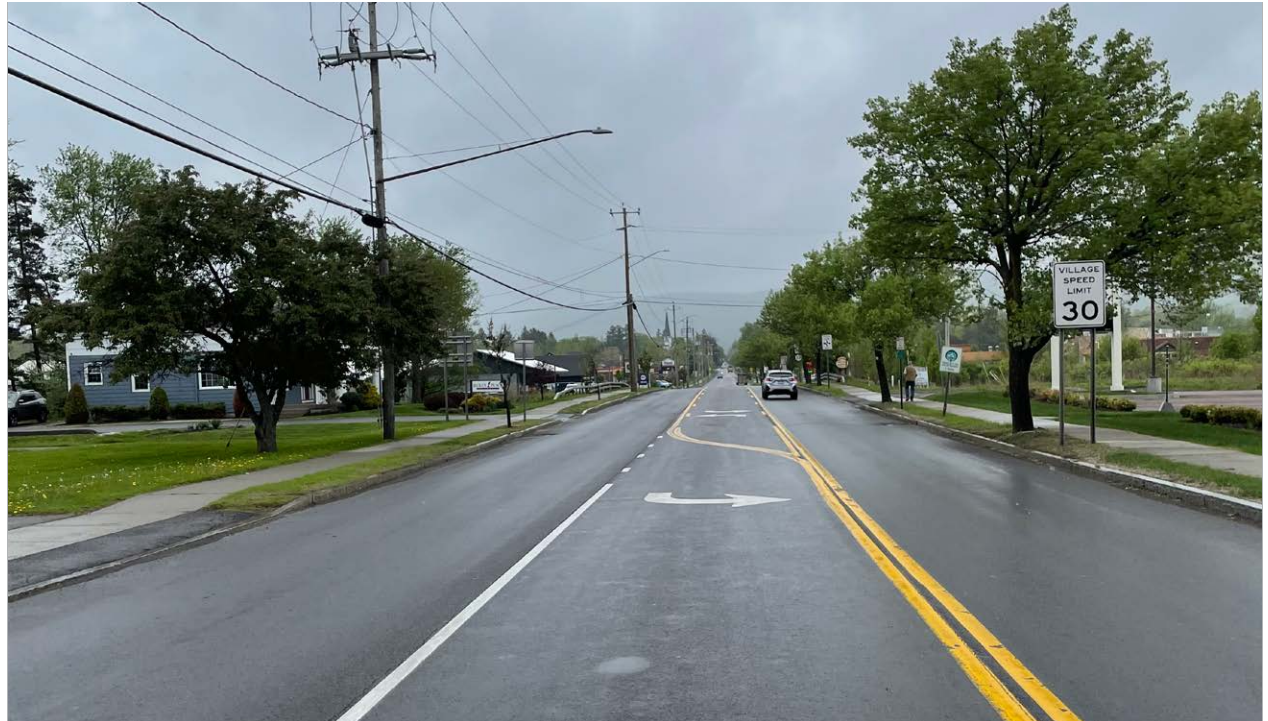
North leg (North St)

As per field visit observations, traffic signals are present at several intersections, but there is no additional signage apart from speed limit signs. Lane markings are slightly faded, and the road surface exhibits minor, infrequent cracking. Sidewalks are present along both sides of the segment. Curb extensions with pedestrian signals are provided at the Main St and NY-13 intersection. Crosswalks, primarily in zebra or ladder styles, are present at most intersection legs, with markings that are clearly visible. Some intersections also feature parallel line crosswalks, while most curbs have accessible ramps with tactile surfaces. One crosswalk at the NY-38/Freeville Rd intersection spans approximately 80-ft.

High-visibility crosswalks use patterns (i.e., bar pairs, continental, ladder) that are visible to both the driver and pedestrian from farther away compared to traditional transverse line crosswalks. High-visibility marked crosswalks are recommended at the intersections of Main St and NY-13 and Freeville Rd and NY-13 to increase pedestrian safety.
